Identification of early operational defects in photovoltaic modules: A case study of a 24.9 MWp solar PV system in Sumatra, Indonesia

This study investigates early operational defects in a 24.9 MWp solar PV system located in Sumatra, Indonesia, within its first two years of operation. The primary objective is to identify key issues affecting performance, reliability, and energy output. Field observations revealed several critical defects, with hotspot formation being the most dominant issue. Hotspots, caused by partial shading, cell mismatches, or module damage, result in excessive localized heating, leading to material degradation and significant power losses. Additional defects included glass cracking (282 cases), primarily linked to hotspots and mechanical impacts, and 350 cases of junction box failures due to improper sealing, which pose long-term risks of moisture ingress and diode malfunction. Instances of foggy or discolored glass (delamination) were also identified, reducing light transmission and overall efficiency. Shading from external objects and self-shading between PV arrays exacerbated these problems. The study highlights that half-cut modules outperform full-cell m

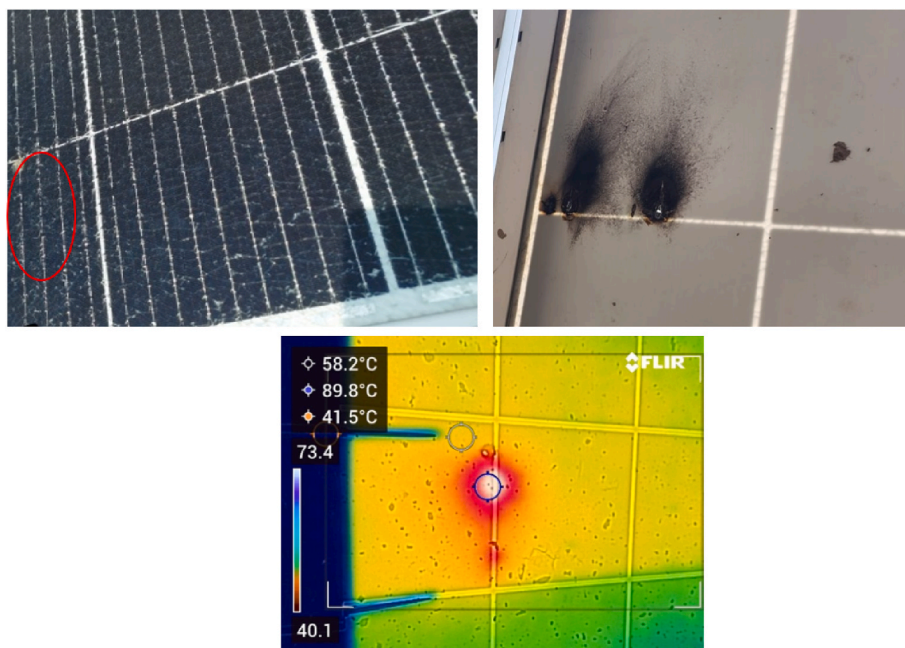
Based on the observations, 282 cases of glass breakage were identified, evenly distributed across all strings. The primary cause of glass cracking is linked to interconnected events, with hotspot formation being the most significant contributor. This is characterized by signs such as burnt ribbons, burnt backsheets, diode failures within the junction box leading to elevated temperatures, and sudden temperature fluctuations caused by transitions from hot to rainy weather, which eventually result in glass fractures. Fig. 2 shows a sample photograph of glass cracking on the front side and its impact on the ribbon, which appears burnt from the front to the back side, caused by a hotspot.

Glass breakage often begins with excessive heat and the formation of hotspots on specific sections of the PV modules that are vulnerable to

Fig. 2. Glass cracking and ribbon burnt caused by hotspot.

damage. This sequence of events occurs repeatedly and cumulatively, accelerating the degradation process. While hotspots and mechanical impacts are dominant factors, other potential causes cannot be ruled out, such as lightning induction, high air humidity, and fluctuating ambient temperatures. These multiple factors underscore the complexity of PV module defects and highlight the importance of comprehensive monitoring and preventive measures to address early-stage failures.

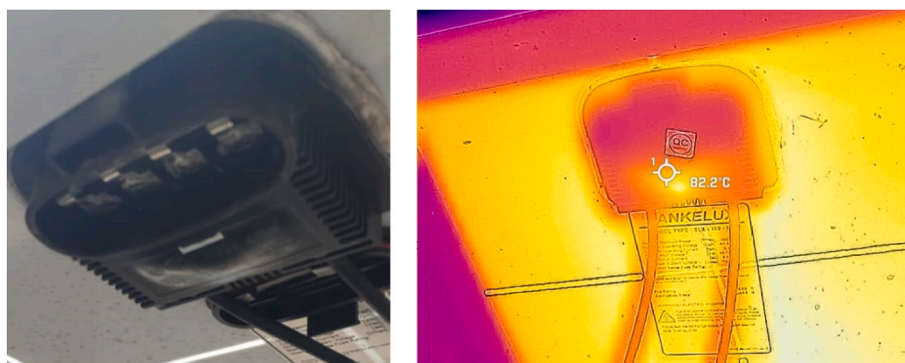
Field observations revealed 42 PV modules with junction boxes exhibiting swelling or bulging. In general, this issue is caused by elevated temperatures resulting from a shorted bypass diode inside the junction box. Measurements taken using a thermal imaging camera (Fig. 3) showed that the temperature of the problematic junction boxes reached as high as 82 °C or above, indicating abnormal heating conditions.

Fig. 3. Sample photograph of junction box swelling.

Addressing junction box swelling requires timely detection and replacement of faulty diodes or modules to prevent further damage, improve system performance, and ensure the longevity of the PV system. Regular monitoring using thermal imaging technology is essential for identifying and mitigating such issues early.

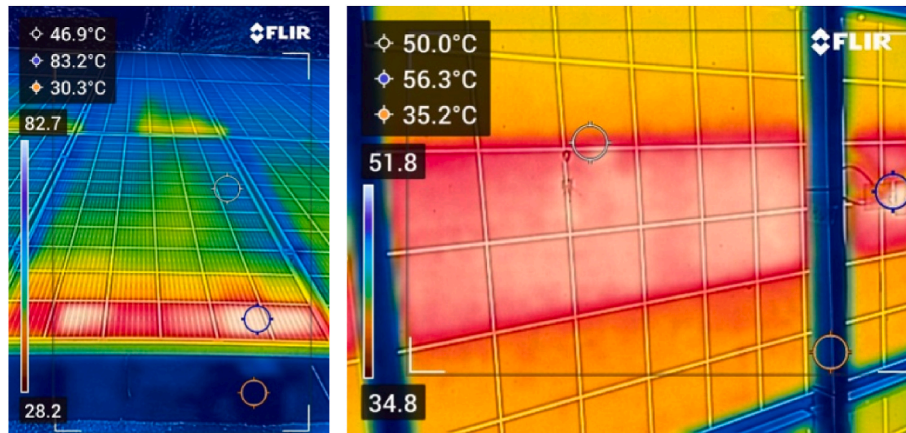
In cases where the swelling was observed, it was also noted that a series of solar cells connected to the shorted diode experienced temperature increases. This condition suggests a direct correlation between shorted diodes and localized overheating in the affected cells. Fig. 4 highlights the PV module cells associated with shorted diodes, where the

This phenomenon has a significant impact on the performance of the PV module. The overheating caused by the shorted diodes results in partial shading effects and energy losses within the module. Over time, this reduces the overall power output of the string to which the affected module belongs, diminishing system efficiency and reliability.

Fig. 4. Higher temperatures observed in cells with shorted diodes.

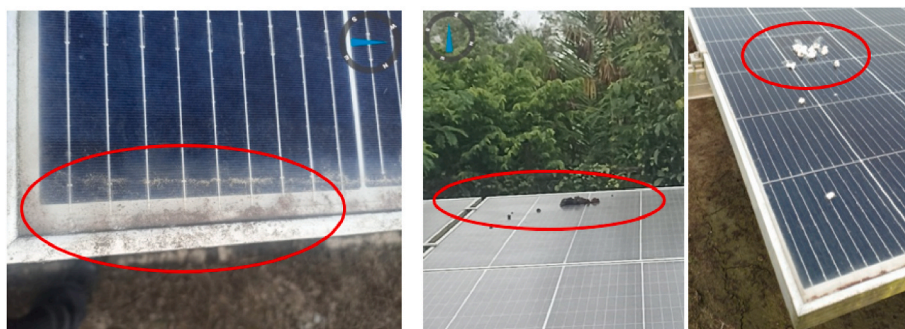
The PV system installation, which is ground-mounted, is located in an open area surrounded by vacant land and trees. Such environmental conditions make the system susceptible to dust, soil, and other dirt unintentionally adhering to the surface of the PV modules. This issue is observed across nearly the entire system, though with varying degrees of severity.

Fig. 5. Unexpected soil and dirt on the PV Module.

The impact of dust and soiling on PV systems is significant and requires regular maintenance and cleaning to ensure optimal energy output. Without proper cleaning, the performance degradation may accumulate over time, leading to permanent damage to the cells and further reducing the system's efficiency. Implementing scheduled cleaning practices and exploring self-cleaning solutions, such as anti-soiling coatings or automated cleaning systems, can help mitigate this problem in dusty environments. Additional studies on the effects of nonuniform PV soiling have been presented in previous works, as referenced in Refs. [9,21,22].

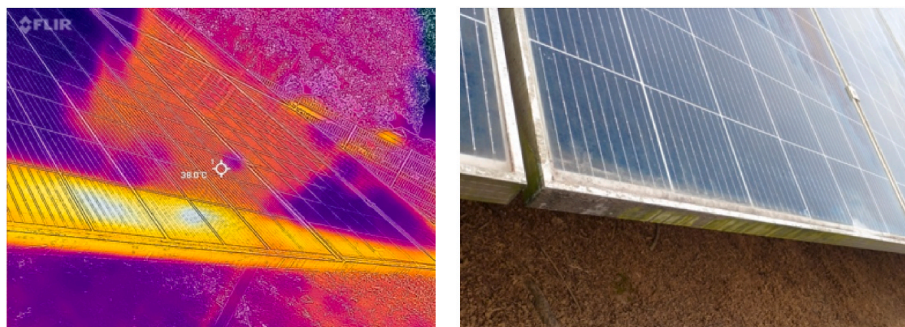
Furthermore, the accumulation of dust on the module surface causes localized temperature increases in affected cells due to reduced energy conversion efficiency. This condition exacerbates the hotspot effect, as the covered cells are unable to dissipate heat effectively. Thermal imaging measurements clearly demonstrate elevated cell temperatures in areas covered by dust or dirt. Fig. 6 shows an example of thermal imaging where a noticeable temperature rise is observed in dust-affected

Fig. 6. Temperature rise caused by soiling.

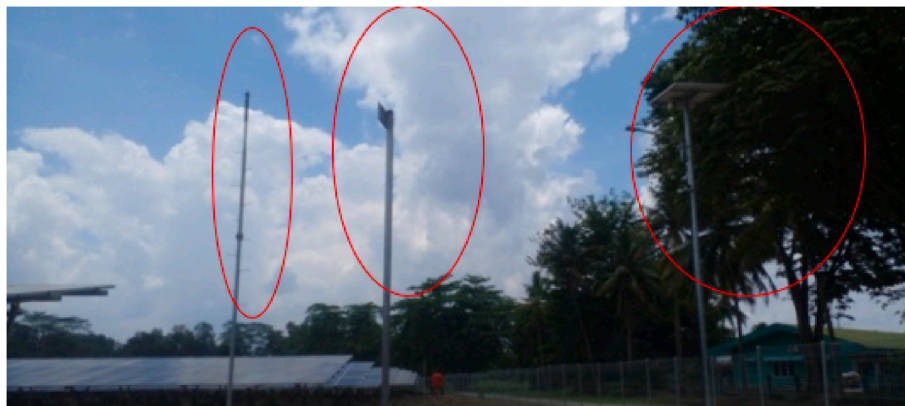
Fig. 7. Potential shading caused by surrounding objects on the PV system.

To mitigate these issues, proper initial system design and planning are crucial. Factors such as module spacing, system orientation, and consideration of surrounding structures must be carefully evaluated during the design phase to minimize shading risks. Addressing shading challenges early can help optimize system performance, ensuring

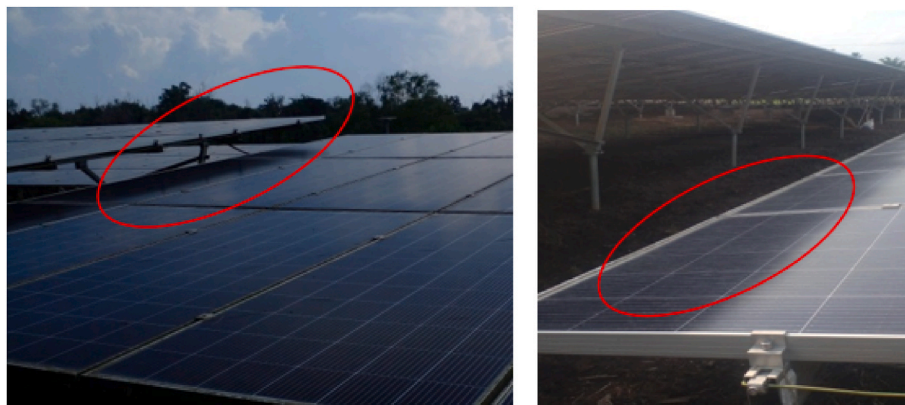
Additionally, shading caused by the PV system itself on neighboring PV arrays was also identified, particularly during low solar altitude in the early morning or late afternoon (Fig. 8). This phenomenon occurs when shadows are cast by one part of the system onto adjacent modules, creating partial shading conditions. Although this shading is relatively short-lived, it can significantly impact the overall performance and energy output of the PV system by reducing efficiency and introducing power losses.

Fig. 8. Shading caused by the PV system itself.

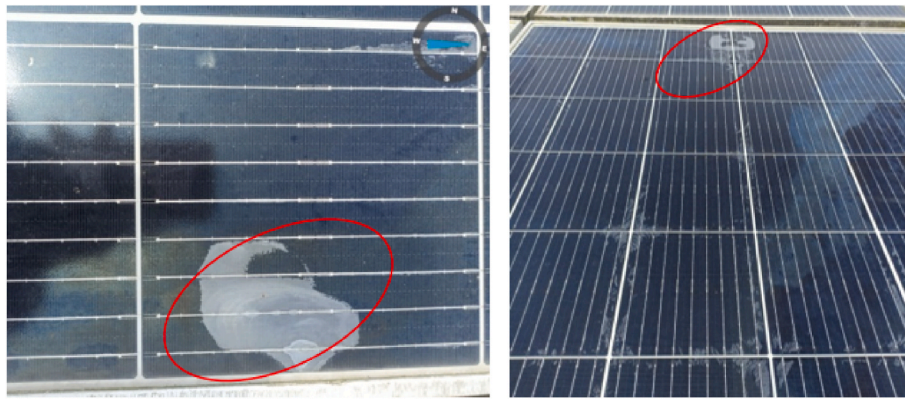
Field observations also identified approximately 7 cases where the glass of PV modules exhibited fogging or discoloration, often in the form of delamination (Fig. 9). This condition is believed to occur as a result of glass cracking in the PV modules, which may stem from various causes, such as hotspot formation or impact from falling objects, as previously discussed.

the glass to reach the solar cells. This results in a decline in module efficiency and energy output over time. Delamination, a form of material separation within the PV module layers, can worsen due to moisture ingress, temperature fluctuations, and the natural degradation of materials. Once initiated, delamination accelerates further deterioration, particularly under prolonged exposure to harsh environmental conditions, such as high humidity, heavy rainfall, and extreme temperature variations.

Fig. 9. Delamination of PV module glass.

These issues underscore the importance of quality control during manufacturing to ensure robust glass and encapsulation materials are used. Additionally, regular monitoring and maintenance of PV systems are necessary to detect early signs of fogging, discoloration, or delamination. Prompt identification and replacement of defective modules can prevent further losses and ensure the long-term reliability and efficiency of the PV system.
